EXCAVATION AND REPAIR OF SUN TEMPLE MESA VERDE NATIONAL PARK

DEPARTMENT OF THE INTERIOR
OFFICE OF THE SECRETARY
1916

EXCAVATION AND REPAIR OF SUN TEMPLE.

By J. WALTER FEWKES, *Bureau of American Ethnology.*

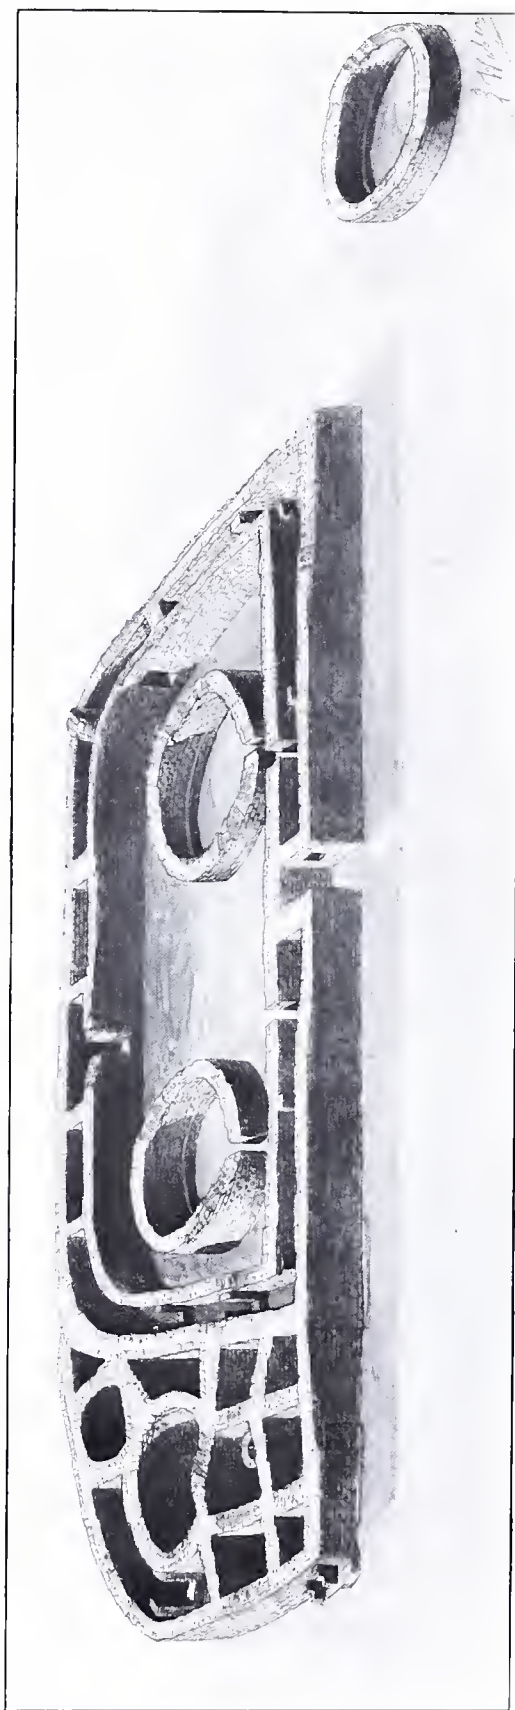
FIG. 1.—BIRDSEYE VIEW OF SUN TEMPLE, LOOKING NORTHEAST.

(Scale, $24\frac{1}{2}$ feet to 1 inch.)

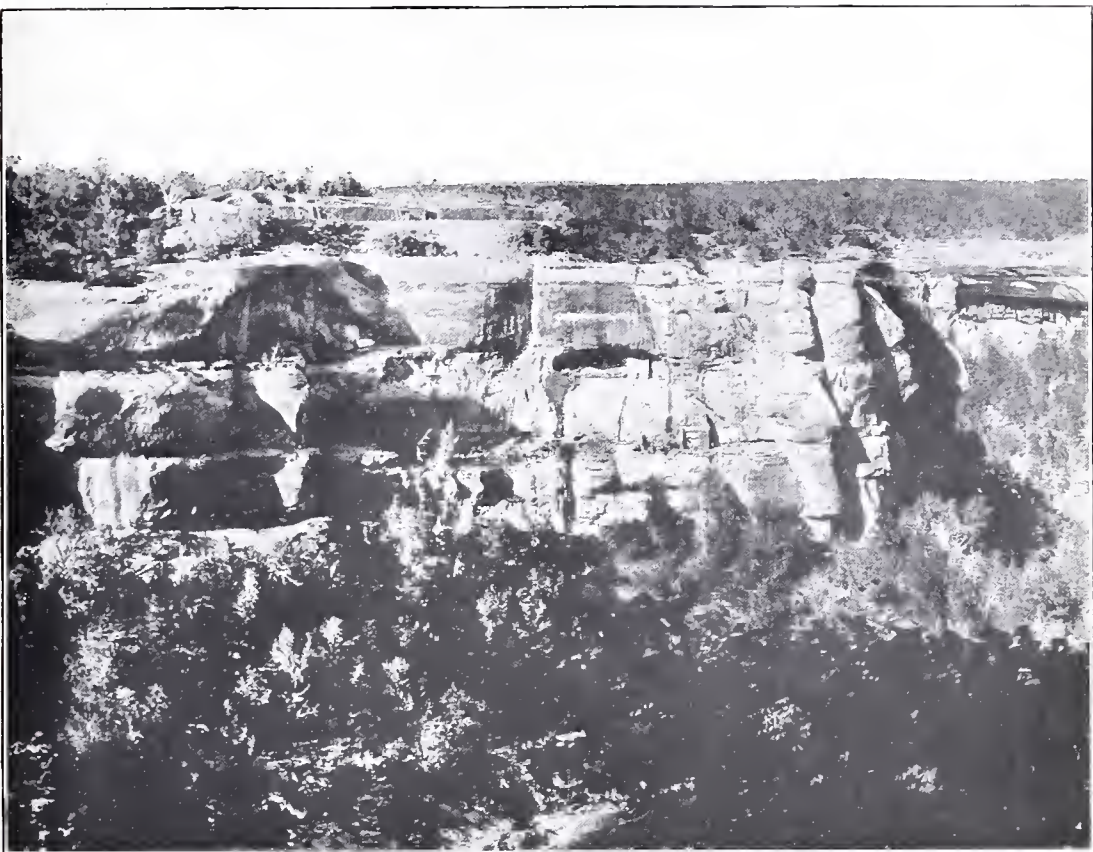
FIG. 2.—VIEW OF SUN TEMPLE AND CLIFF PALACE.

The ruin was purposely constructed in a commanding situation (fig. 2) in the neighborhood of large inhabited cliff houses. It sets somewhat back from the edge of the canyon, but near enough to

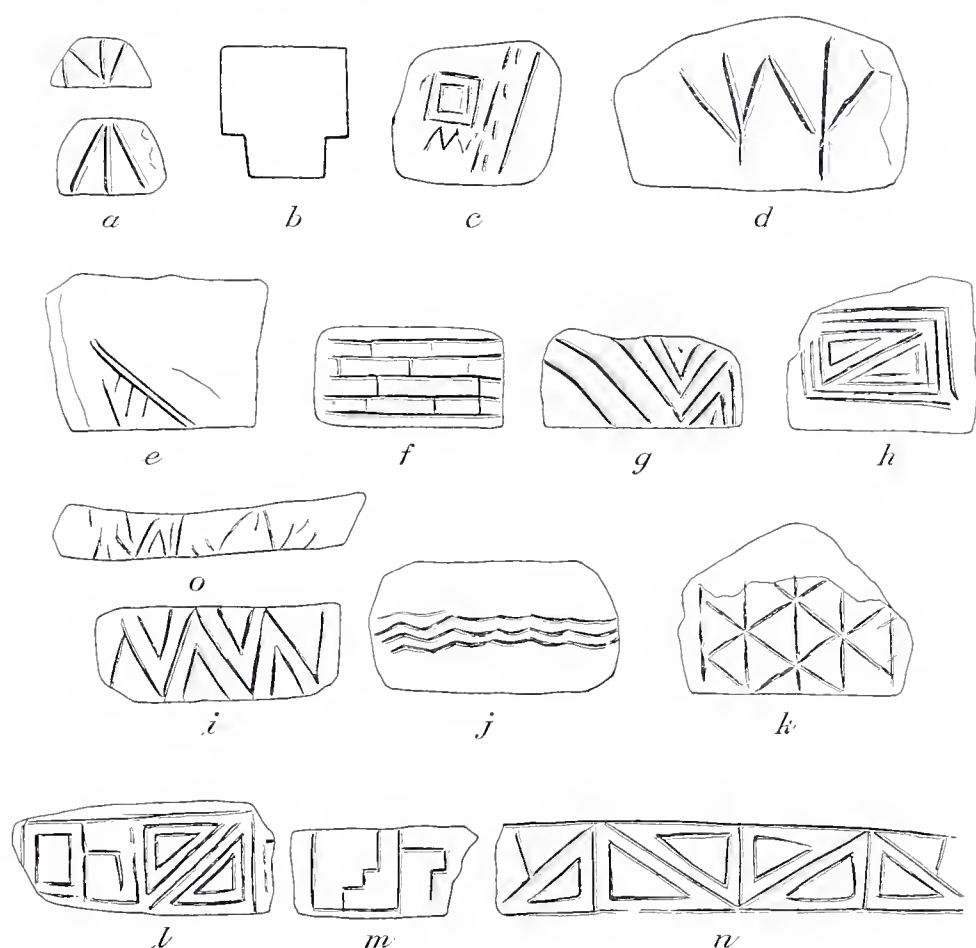
FIG. 4.—TYPICAL DESIGNS ON STONES FROM THE WALLS.

A figure (fig. 4*c*) representing a ladder leaning against a wall is incised on the left-hand side of the entrance to room *o*. On one side, near it, is an outline of a T-shaped door (fig. 4*b*), above which

is a cross, not very deeply cut in the rock. Near the top of the inner wall of room *g*, on the west side, there is an incised figure (fig. 4*h*), commonly found on pottery and on the inner wall of the southwest corner of the plaza another pattern is obscurely indicated.

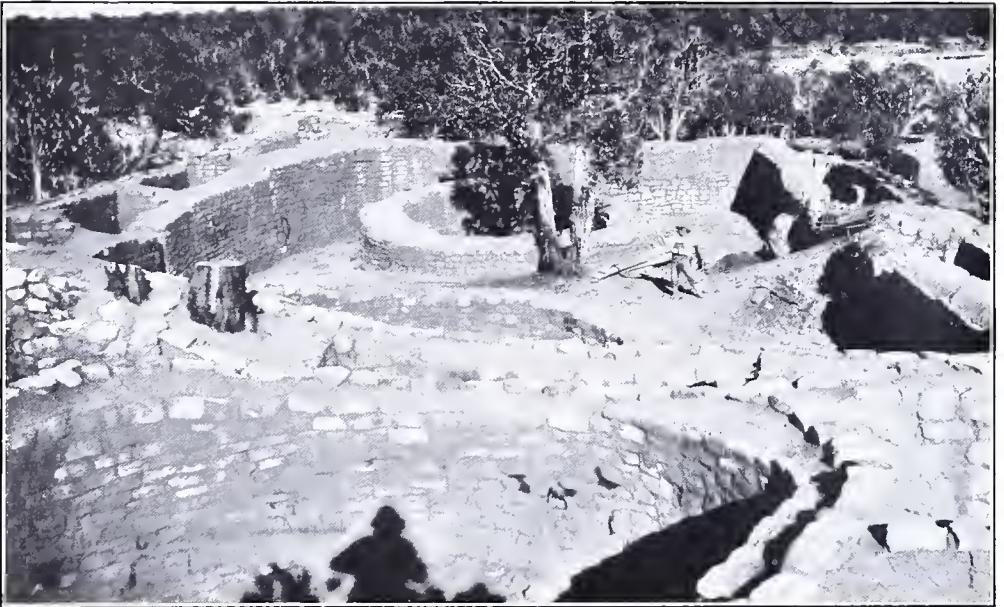
The surfaces of the walls of many rooms (fig. 5) have been rubbed smooth, the marks of pecking on individual stones not being as well

FIG. 5.—INTERIOR OF RUIN, LOOKING EAST, SHOWING CEDAR STUMP.

shown as on the facing of the outer walls. Roots of trees formerly growing on the ruin have made their way between the courses of stone and can still be seen in the walls.

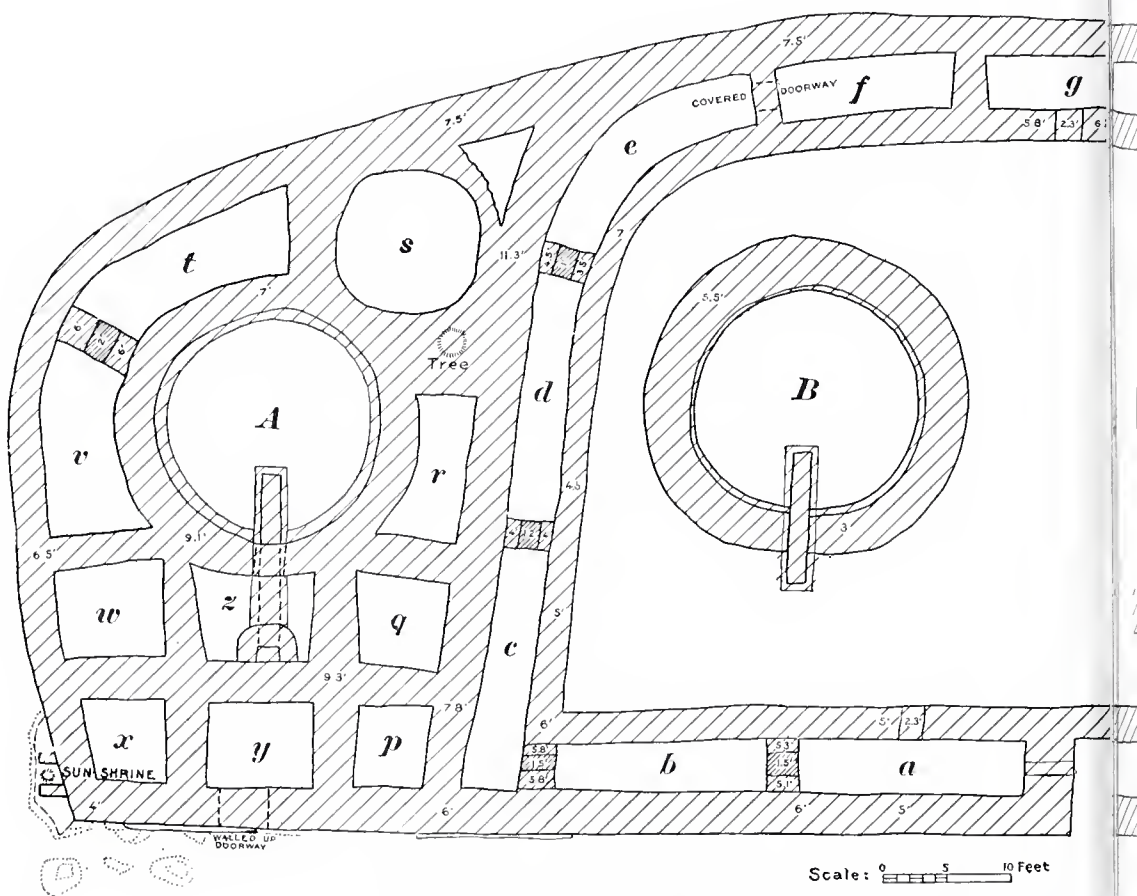
FIG. 7.—GROUND PLAN OF SUN TEMPLE, MESA VERDE NATIONAL PARK

The ground plan, shown in figure 7, has been well compared to the letter D. The building is formed of two sections, the larger of which taken separately is also D-shaped and may be called the original building, while the smaller, forming the west end, is of later (?) construction and may be known as the Annex. The south wall, which is straight, is common to both original building and Annex and extends from the southeast corner of the ruin directly east-west 121.7 feet. The portion of this wall from the recess to the east corner has exactly the same length as that to the junction of the original building with the Annex. The western end of the original building, on the south

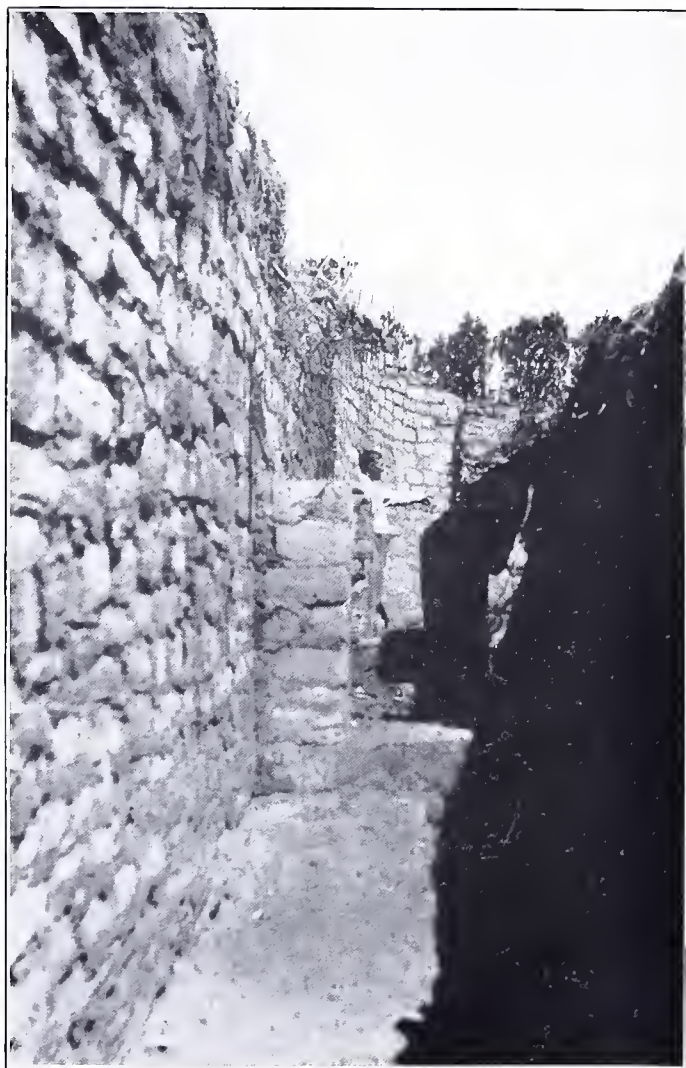
FIG. 8.—WEST WALL OF ROOMS *d* AND *e*, SHOWING DOORWAY.

t-v. The lintels which remained were much decayed and sagged under the weight of the wall above them, so much so that a brace of modern construction was introduced to support them. The lintel that held up the covered doorway of room *r* and that which supported the floor of room *z* above the trench leading into kiva A, were partially intact, but most of the lintels had to be replaced by modern beams, the originals being much decayed (fig. 8).

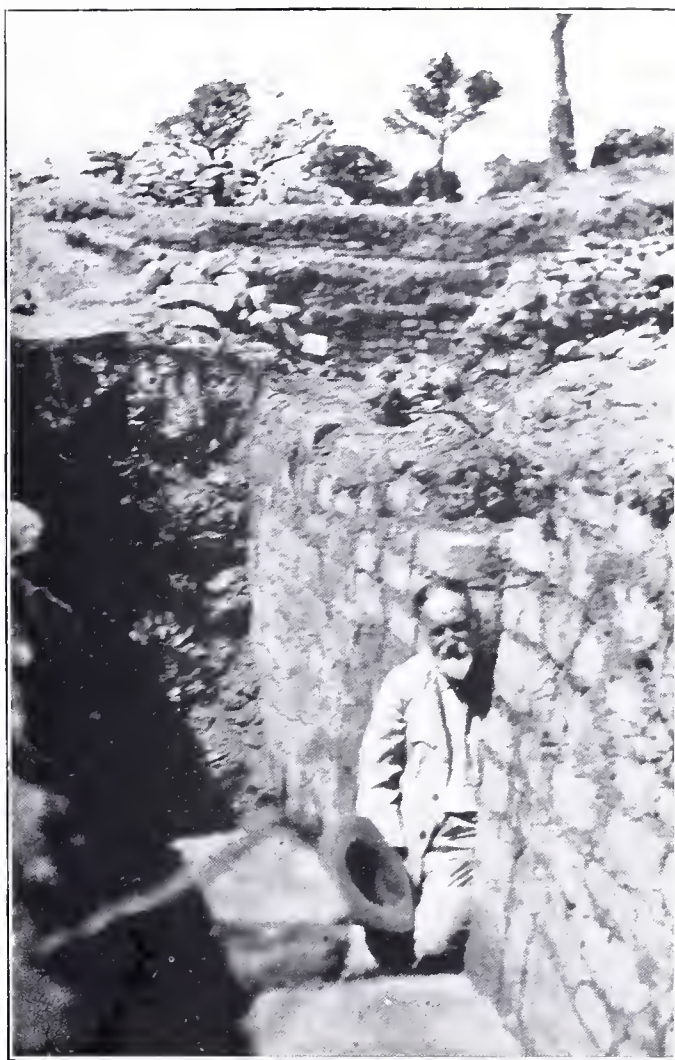
FIG. 9.—WEST END OF ROOM *o*, PARTLY EXCAVATED.

Four of the rooms surrounding the plaza were entered directly by doorways; one of these led into room *a*, others into rooms *g*, *k*, and *o*. The thresholds of the doorways are commonly constructed of large, flat, well-trimmed stones. On each side of the doorway are pilasters (fig. 9) the walls of which are upright and the corners made of good masonry (fig. 9). Evidently all the doorways once had wooden lintels

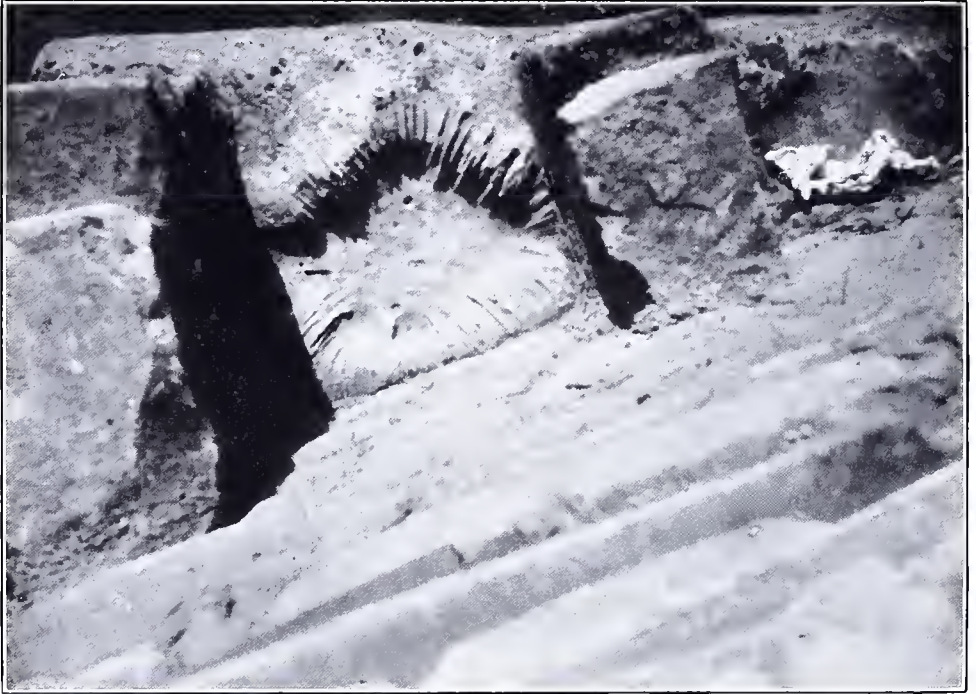
FIG. 10.—SUN SHRINE FROM ABOVE.

One of the most remarkable structures built on the outside walls of the building is near the southwest corner of the Annex. This corner stands on a solid rock that projects about $1\frac{1}{2}$ or 2 feet above the otherwise level foundation of the wall. This cornerstone or foundation of the corner wall protrudes 2 feet beyond the building, and on its upper surface is a fossil with central depressed zone with sharp radiating ridges. The figure (fig. 10) is not artificial,¹ but is possibly helped out by artificial means. A natural object with these charac-

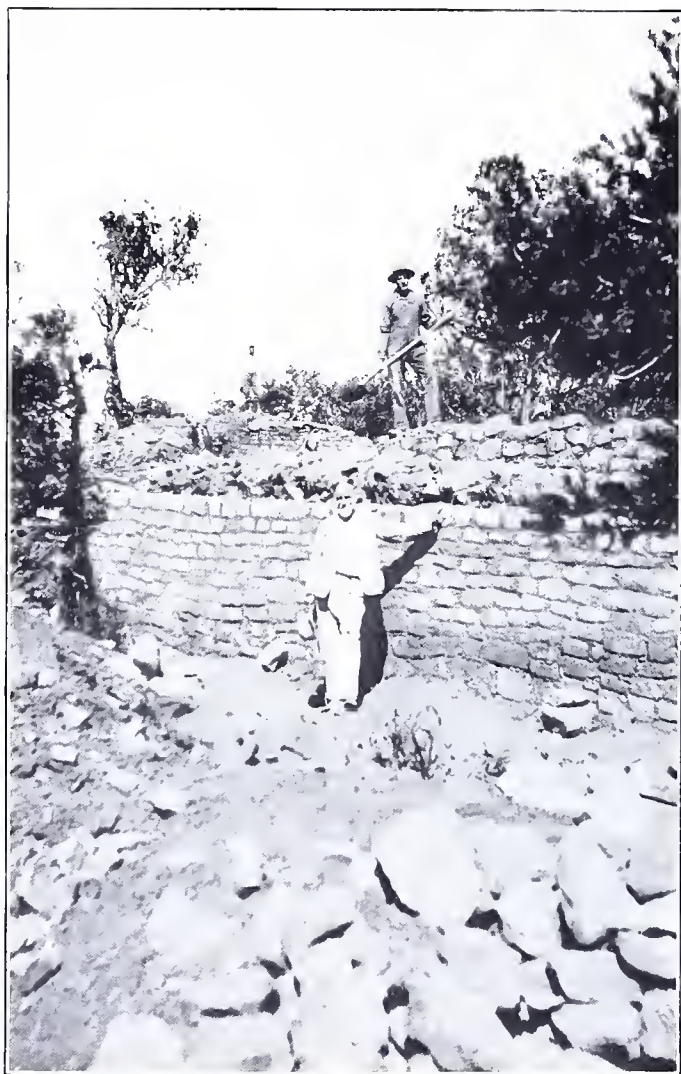
The main causes of destruction of this ruin were not vandals, as at Cliff Palace, but the elements, especially water. After it was abandoned the tops of the walls were exposed to the sky and unprotected either from snow or rain which sometimes falls in torrents. The snow was particularly damaging, for the water from the melting snow percolated between the facings and the core of the wall, and subsequently froze, forcing the facing of the wall away from the central core until it fell. That this was the main cause of deterioration is shown by the fact that as a rule the outer facing of the surrounding wall was more nearly obliterated to a lower level than the inner, and as a rule the core projected often a foot above faces of the wall. The deleterious cause which early led to the overtopping and destruction of walls would be even more potent when they were excavated. Some means had to be devised to prevent a continuation of their destruction (fig. 11).

FIG. 11.—PART OF SOUTH WALL, PARTLY EXCAVATED.

Although the walls of the building were so massive that they remained intact to the height of the top of the mound, they were partially held up by an accumulated débris. The removal of earth and fallen rocks weakened them so much that some provision had to be made to counteract this loss of support. In order to prevent the

water from melting snow from penetrating the walls, or the rain from percolating between the core of the wall and its facing, I placed a cap of cement on the tops of all the walls. The inner facing of the outer walls, as a rule, stood a few courses of stone higher than the outer, and it was necessary to add masonry to bring the outer wall to the level of the core and inner facing. Having leveled the top of

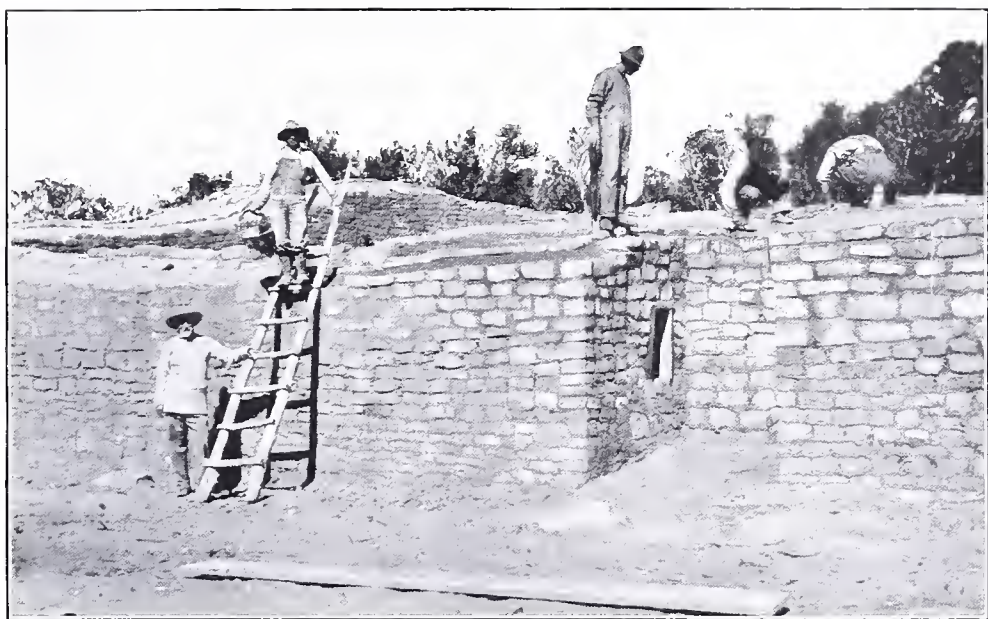
FIG. 12.—CEMENTING WALL OF RECESS IN SOUTH WALL.

the wall, I covered it with small, angular fragments of stone, placing these fragments highest in the middle or over the core. Over this roof-like covering was spread a thick layer of adobe. The top of the wall was thus made in a way to shed water. Over this roof of adobe was spread a layer of Portland cement, 2 inches thick, mixed in proportion of 1 to 5, care being taken to use this cement freely in point-

ing the joints in the facing of the wall in order to prevent the entrance of water in the cracks (fig. 12). The roof shape of this covering or the fact that it is highest in the middle will shed the water and throw it away from the wall without harm. The layer of cement protects the adobe used in pointing the walls and prevents it from being washed from between the stones. Direct action of rain beating on the surface or outside of the wall could not be prevented in this way.

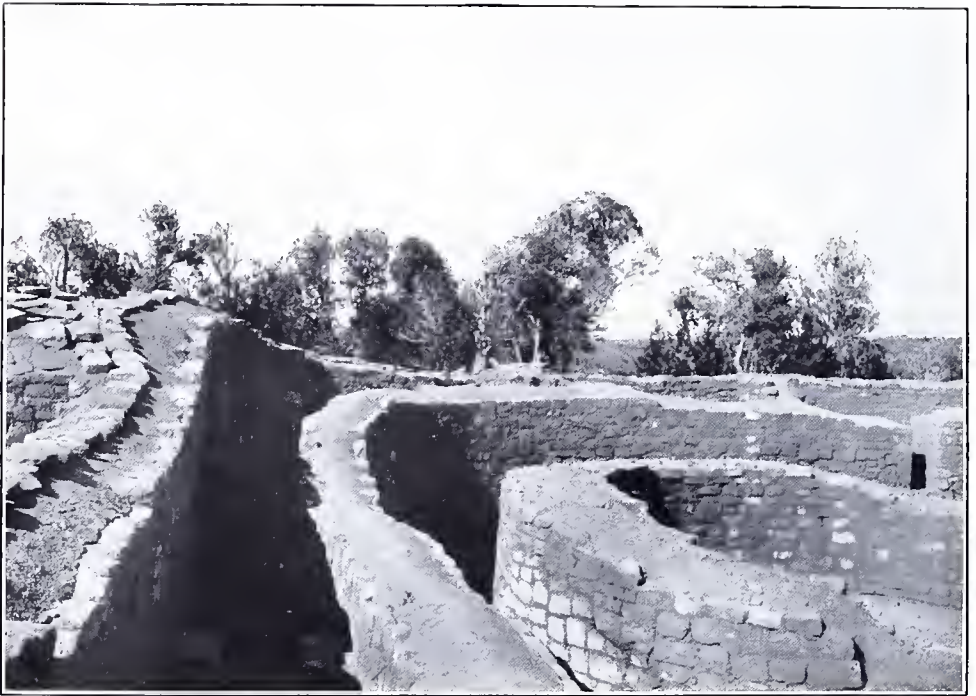
FIG. 13.—WEST ROOMS OF ORIGINAL BUILDING.

wearing away of the cement by anyone who desired to walk on top of the walls, a row of stepping stones (fig. 13) firmly set in place was provided.

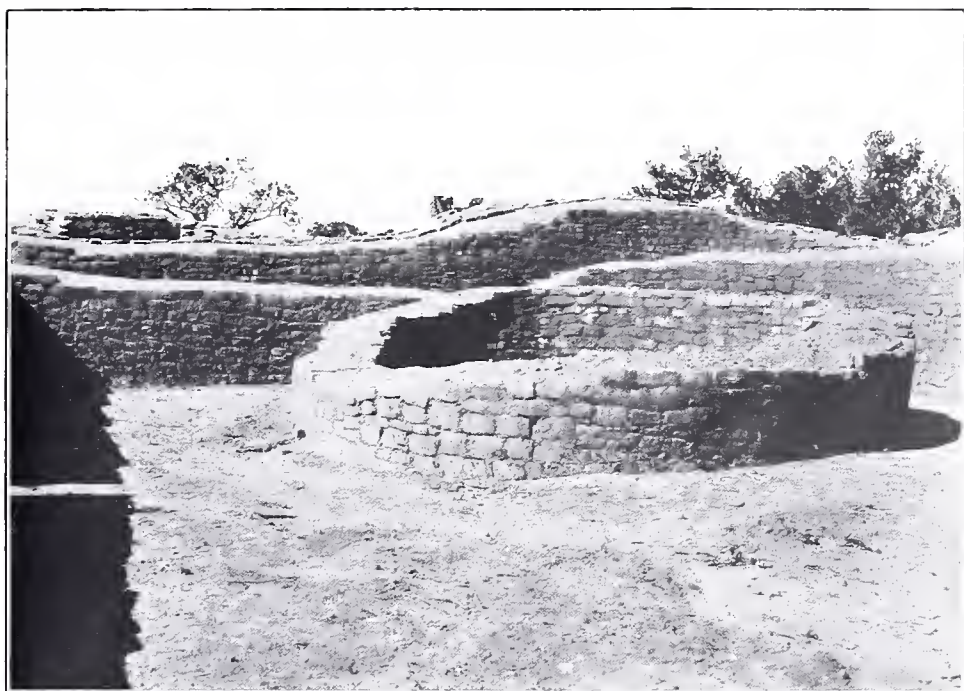
mound. No one can tell the length of this interval in years. We have, however, knowledge of the lapse of time since the mound had accumulated enough soil on its surface to support growth of large trees. In the Annex, between rooms *r* and *s*, near the summit of the highest wall, which is 11 feet 3 inches high, there grew a juniper or red cedar of great antiquity, alive and vigorous when I began work. This tree undoubtedly sprouted after the desertion of the building, and grew after a mound had developed from fallen walls. Its roots penetrated into the adjacent rooms and derived nourishment from the soil filling them. Necessarily when these roots were cut off, thereby killing the tree, I was obliged to fell it, but the stump remains, cut off about a foot above the ground (fig. 14). Three hundred and

sixty annual rings were counted on a section of this tree by Mr. Gordon Parker, supervisor of Montezuma National Forest. Its heart is decayed, but its size suggests other rings and that a few more years can be added to its age. It is not improbable that this tree began to grow on the top of the Sun Temple mound shortly after the year 1540 when Coronado first entered New Mexico, but how great an interval elapsed during which the walls fell to form the mound in which it grew, and how much earlier the foundations of the ruined walls were laid no one can tell. A conservative guess of 250 years is allowable for the interval between construction and the time the cedar began

FIG. 14.—WEST END OF PLAZA, SHOWING KIVA B AND STUMP OF OLD CEDAR.

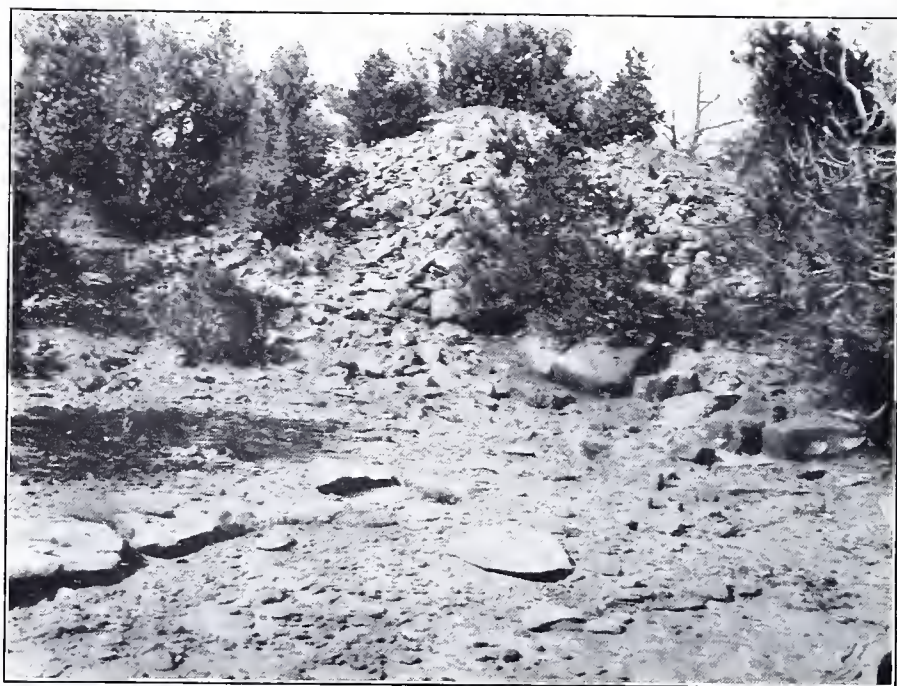
FIG. 17.—SUN TEMPLE, BEFORE EXCAVATION, FROM NORTHEAST.
